Rehabilitation of Distressed Airport Pavements

Using The GlasGrid[®] Pavement Reinforcement System to Mitigate Reflective Cracking

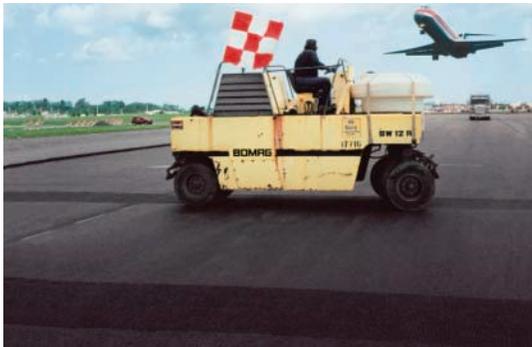
The GlasGrid[®] System becomes the hidden strength in airport pavement structures.

The GlasGrid[®] Pavement Reinforcement System provides additional support to resist the migration of reflective cracks in airport pavement structures. When GlasGrid mesh is “sandwiched” between a leveling course and the surface course asphalt, it becomes the hidden strength in the airport pavement – designed to redirect vertically migrating cracks horizontally, thereby effectively dissipating them.

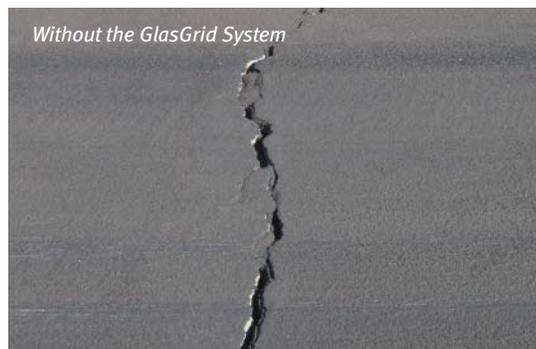
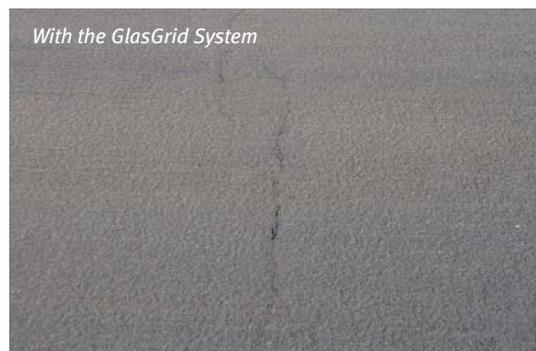
Pavement surface condition following 11 years of post-rehabilitation service.

A site visit on January 31, 2007, showed that following 11 years of service, the runway where the GlasGrid System was installed has resulted in only minor cracking. In contrast, an area that was left unreinforced for comparison purposes demonstrated significantly more severe cracking up to 1 in. wide.
